Manhole Inspection Summary

Manhole # S27S__007MH

Location Address: **1611 Ridgely**

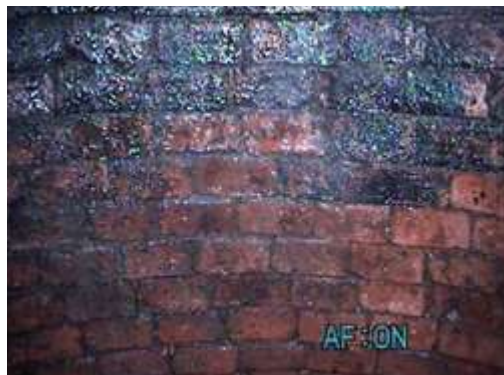
Defect 8

Condition: ☐ Sound ☐ Cracked ☐ Root Intrusion ☐ Loose Brick ☒ **Deteriorated**

Infiltration: ☐ None ☐ Joint ☐ Cracks ☐ Mortar ☐ Roots ☒ **Wall**

Barrel Deterioration, infiltration in barrel

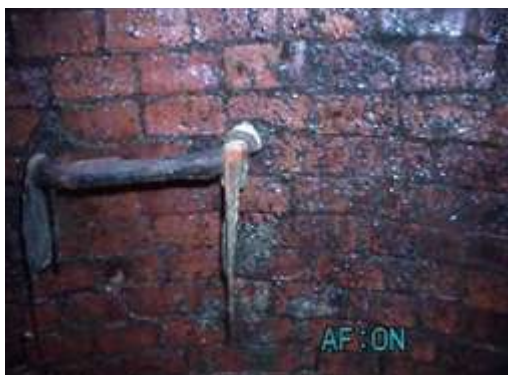
Defect 2

Surcharge ☒ **Evidence Of Surcharge** Depth: **5** (ft.) ☐ Active Surcharge Present

surcharge evidence on steps

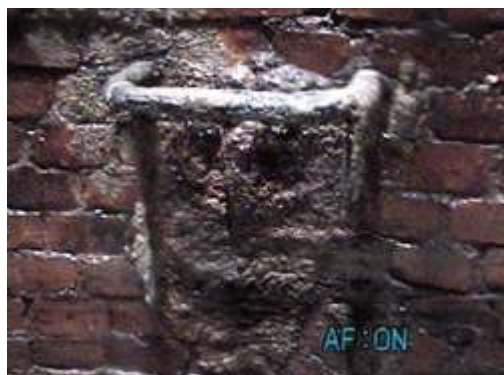
Defect 4

deteriated rungs dripping patch infiltration in barrel

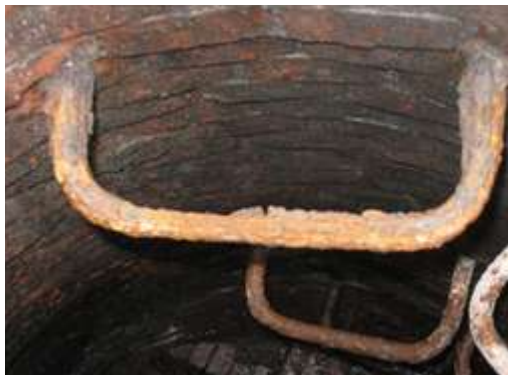
Defect 3

Steps Count: **7** Missing: **0** ☒ **Corroded**

rusted rungs

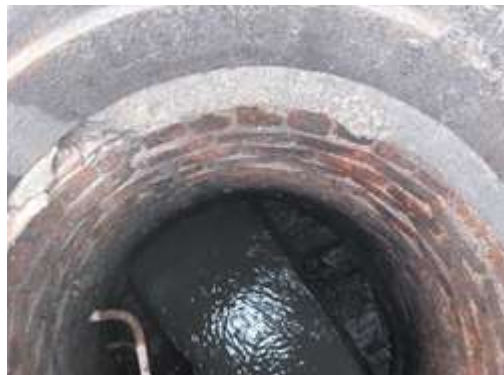
Defect 1

Condition: ☐ Sound ☒ **Cracked** ☐ Root Intrusion ☐ Loose Brick ☐ Deteriorated

offset at chimney, cracks in chimney

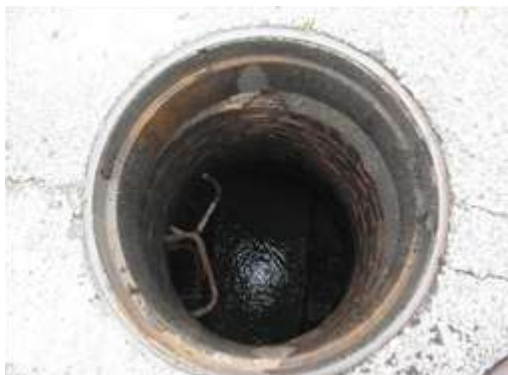
Defect

Frame Offset: **1.5** (in.) Condition: ☐ Sound ☐ Cracked ☒ **Leaks**

frame leaks

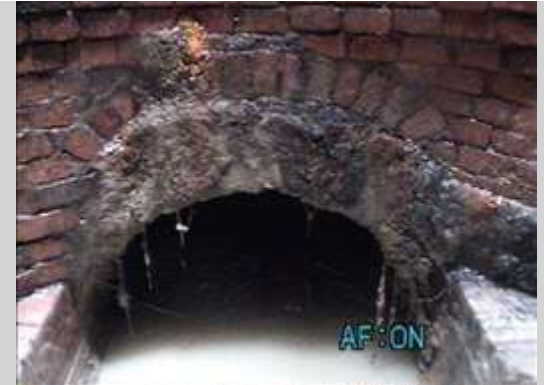
12 O'Clock Outflow

Pipe Height: **38.4** (in.) Rod and Bar (Angled)
Pipe Material: **Clay** ☐ Pipe Lined
Invert Depth: **14.93** (ft.) Flow Characteristics: **Turbulent**
Deposits: ☒ None ☐ Mud ☐ Sludge ☐ Debris ☐ Grease
Silt Depth: **0** (in.) Deposits Extent:
Infiltration: **Dripper** Pipe Seal Cond: **Unknown**

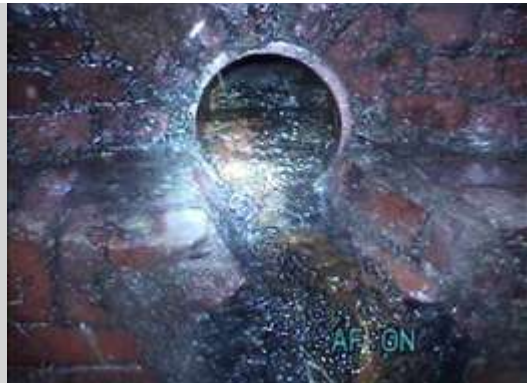
9 O'Clock Inflow

Infiltration: **Evidence** Pipe Seal Cond: **Unknown**
